## **CAFO FACILITY INSPECTION REPORT**

<b>Inspection Date:</b>	<b>March 26, 2014</b>
<b>Facility Name:</b>	<b>Armstrong Egg Farms</b>
<b>Facility Address:</b>	<b>(b) (6)</b>
<b>Authorized Official &amp; Phone:</b>	<b>Ryan Armstrong, VP Operations, (M) 7 [REDACTED]</b>
<b>Mailing Address of Authorized Official:</b>	<b>P.O. Box 2299 Valley Center, CA 92082</b>
<b>NPDES #:</b>	<b>Unpermitted</b>
<b>On-Site Representative &amp; Phone:</b>	<b>Ryan Armstrong, VP Operations (M) 7 [REDACTED] 5/ (O) 760-749-1058</b>
<b>Receiving Water(s):</b>	<b>Not yet determined at time of inspection.</b>
<b>Inspector(s)</b>	<b>Kristine Karlson, EPA Region 9 - 415-947-4297 Michelle Mata, San Diego Water Quality Control Board (SDWQCB) - 619-521-3369 Dat Quach, SDWQCB - 619-521-5899</b>

Armstrong Chicken Farms Clean Water Act inspection (\_\_\_ of 88 photos)  
All photos taken by Kristine Karlson, EPA, on March 26, 2014.

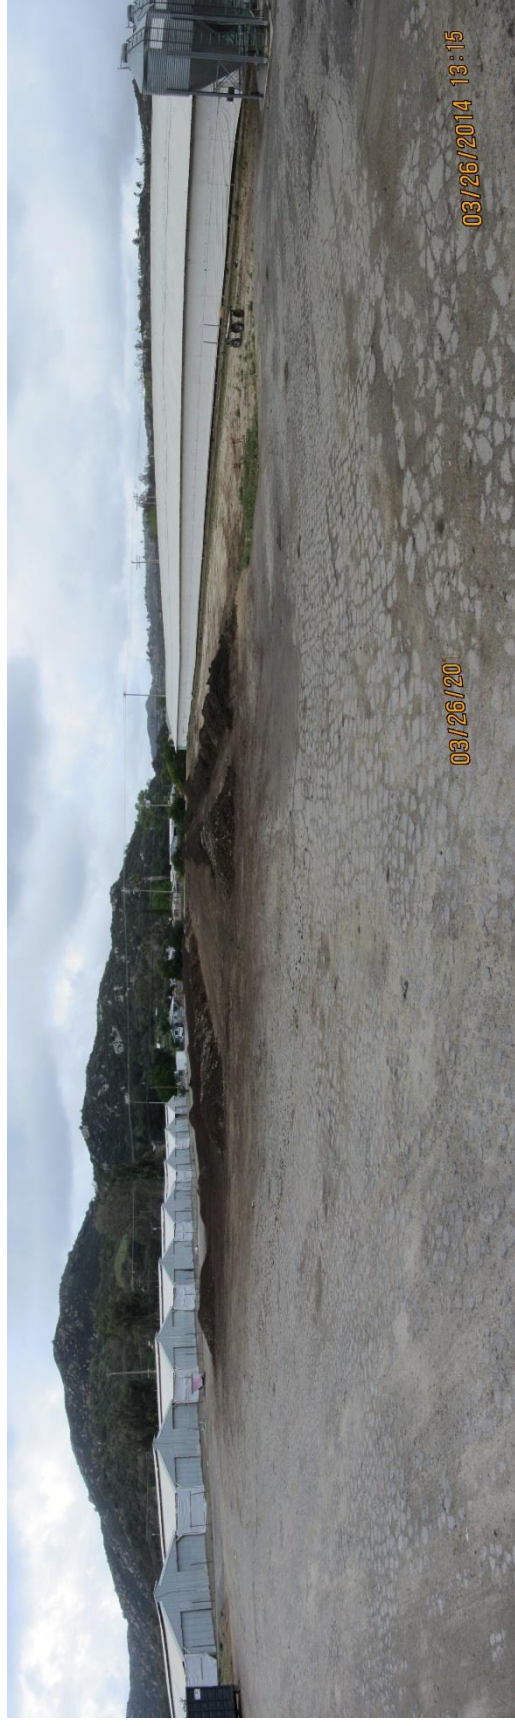
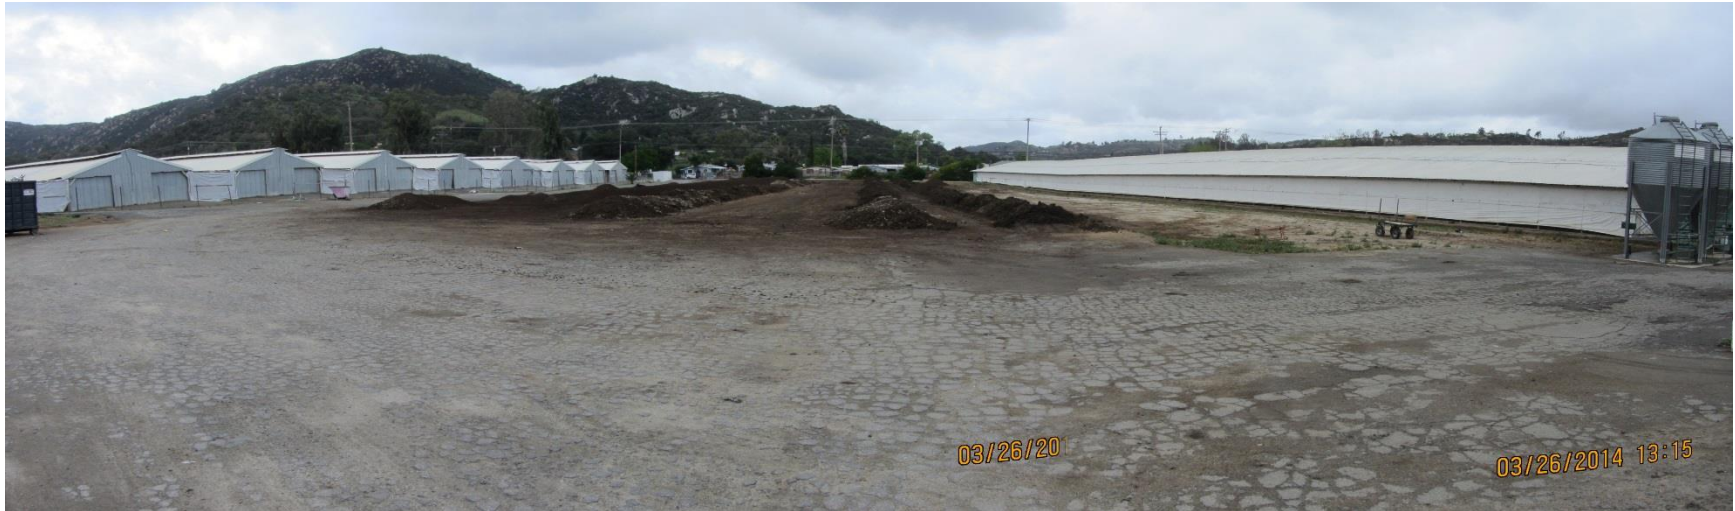
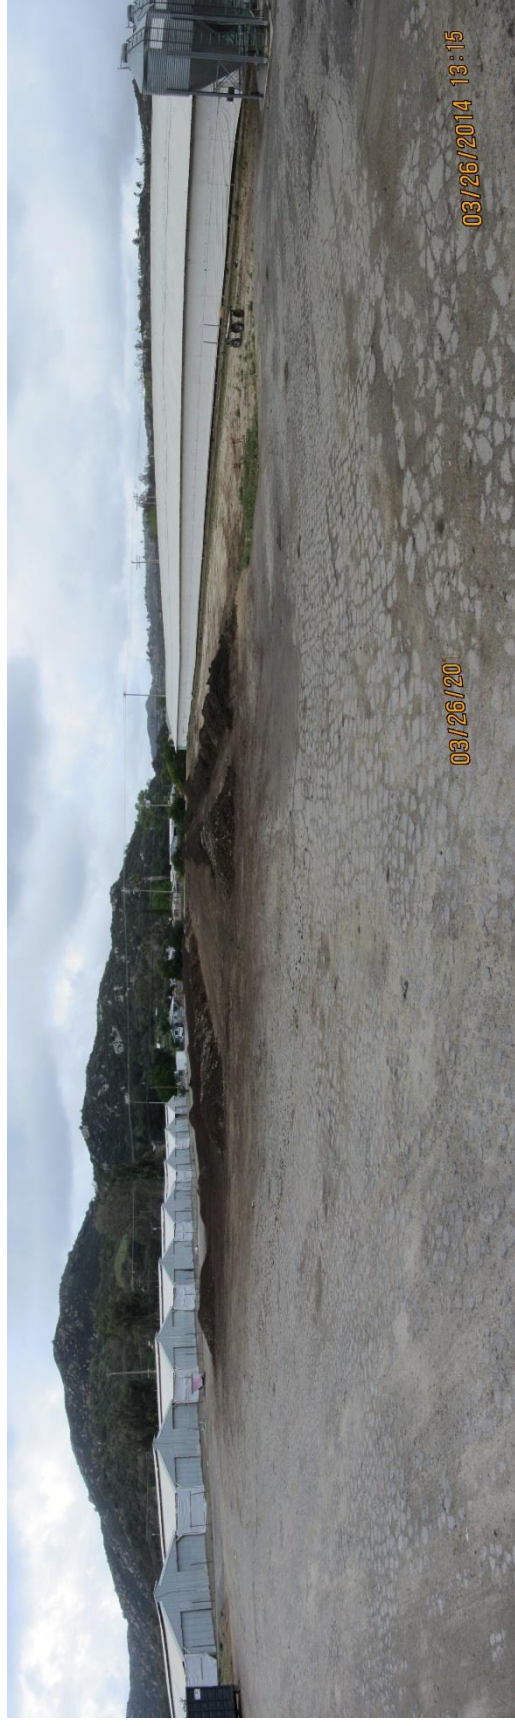
Photo 5 –Manure piles, located in the center of the facility. Manure is piled in rows to dry on a paved area. View is to the west. This image represents three photographs, stitched together.

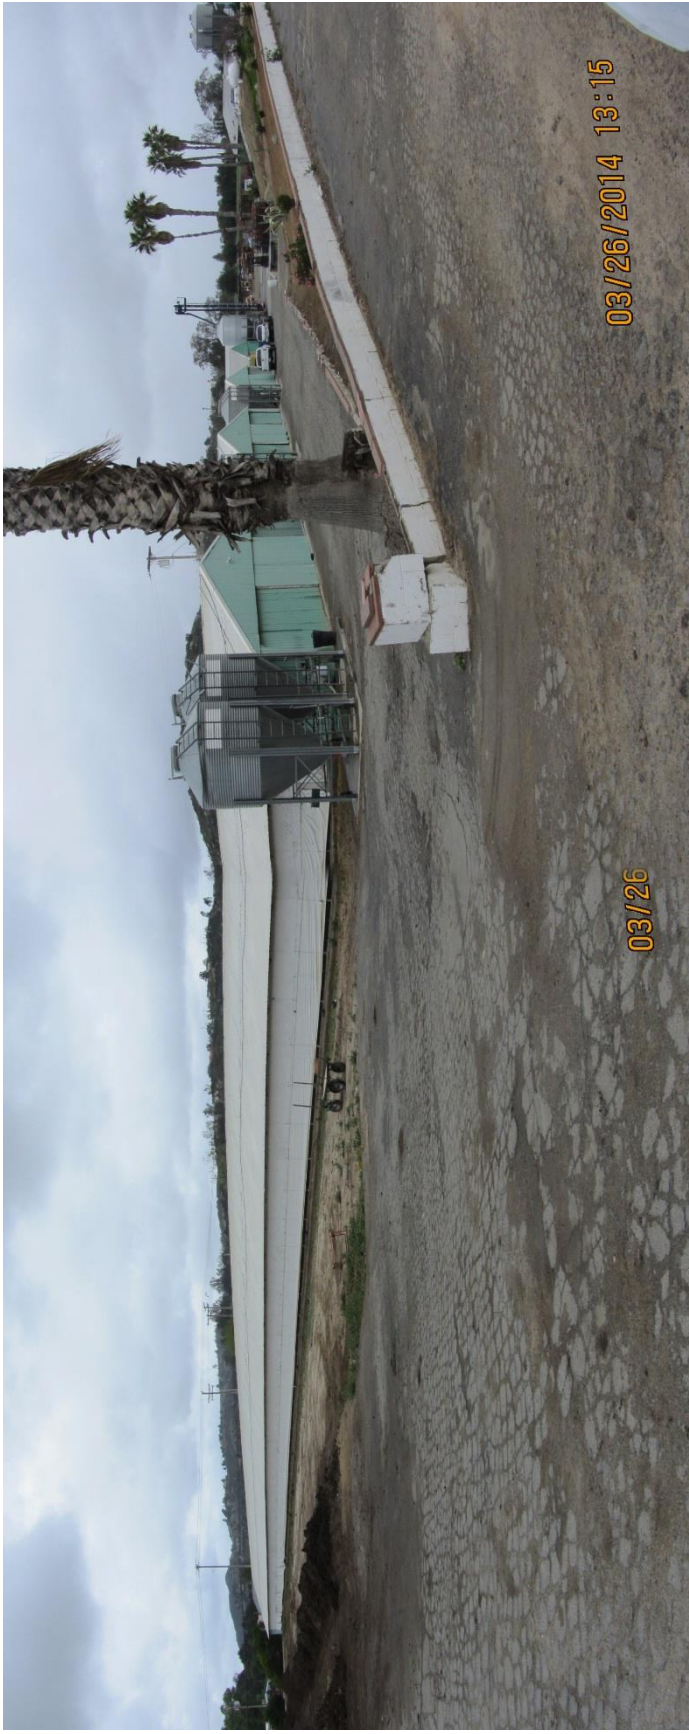
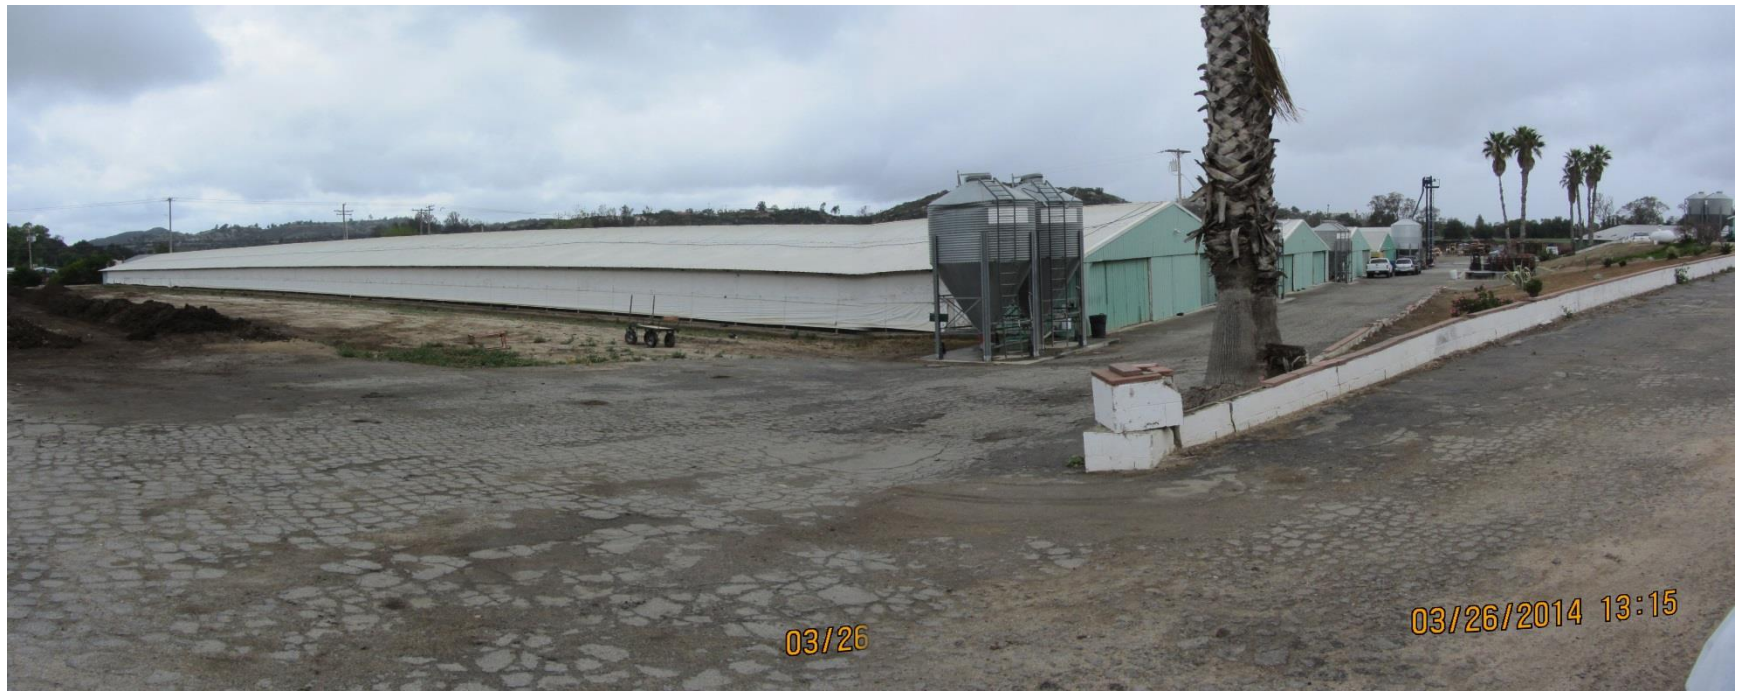
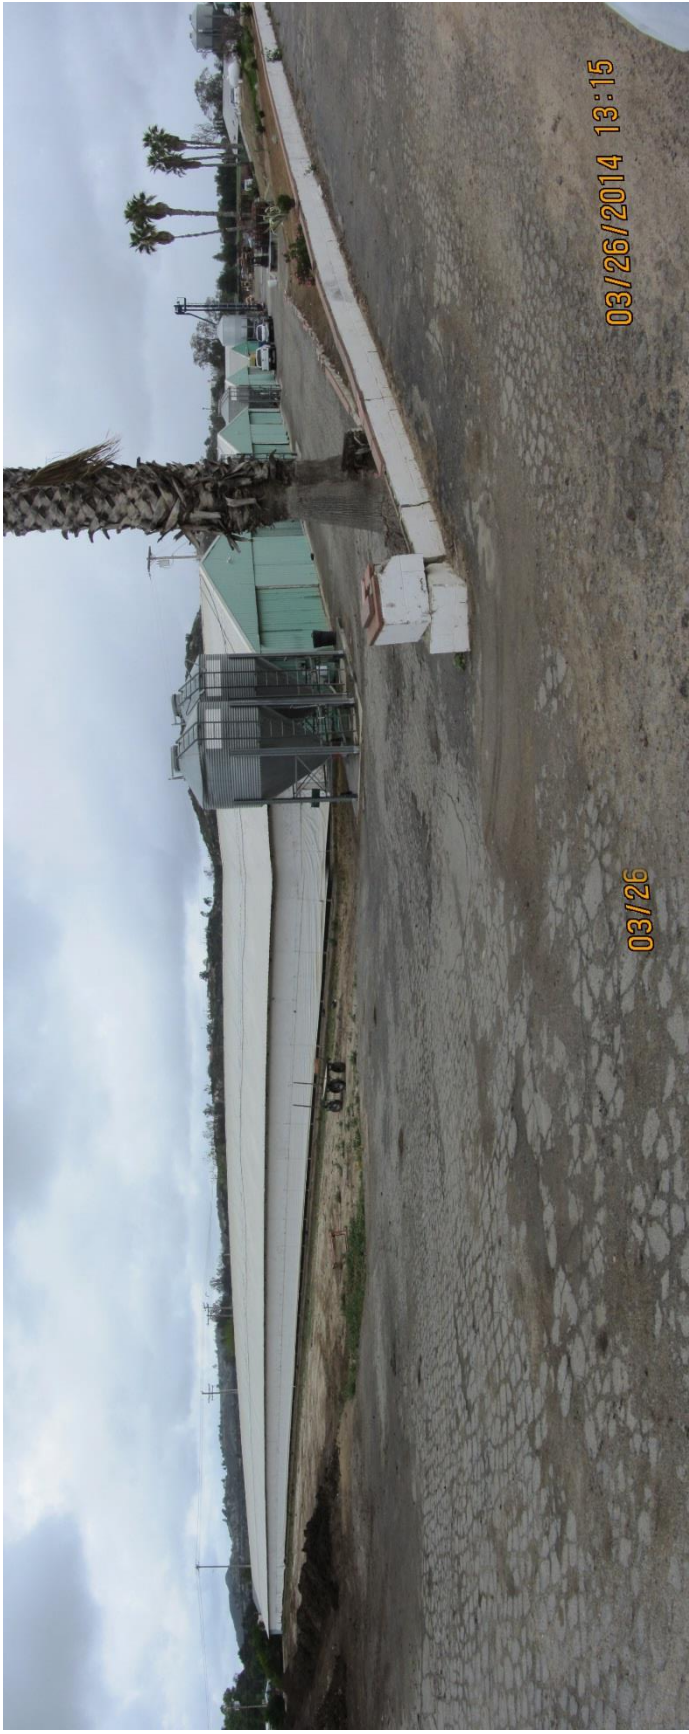
Photo 6 – View of hen houses to the north of the manure piles. View is to the northwest. There is an area between the manure piles and the hen house immediately to the north that is unpaved. This image represents two photographs stitched together.

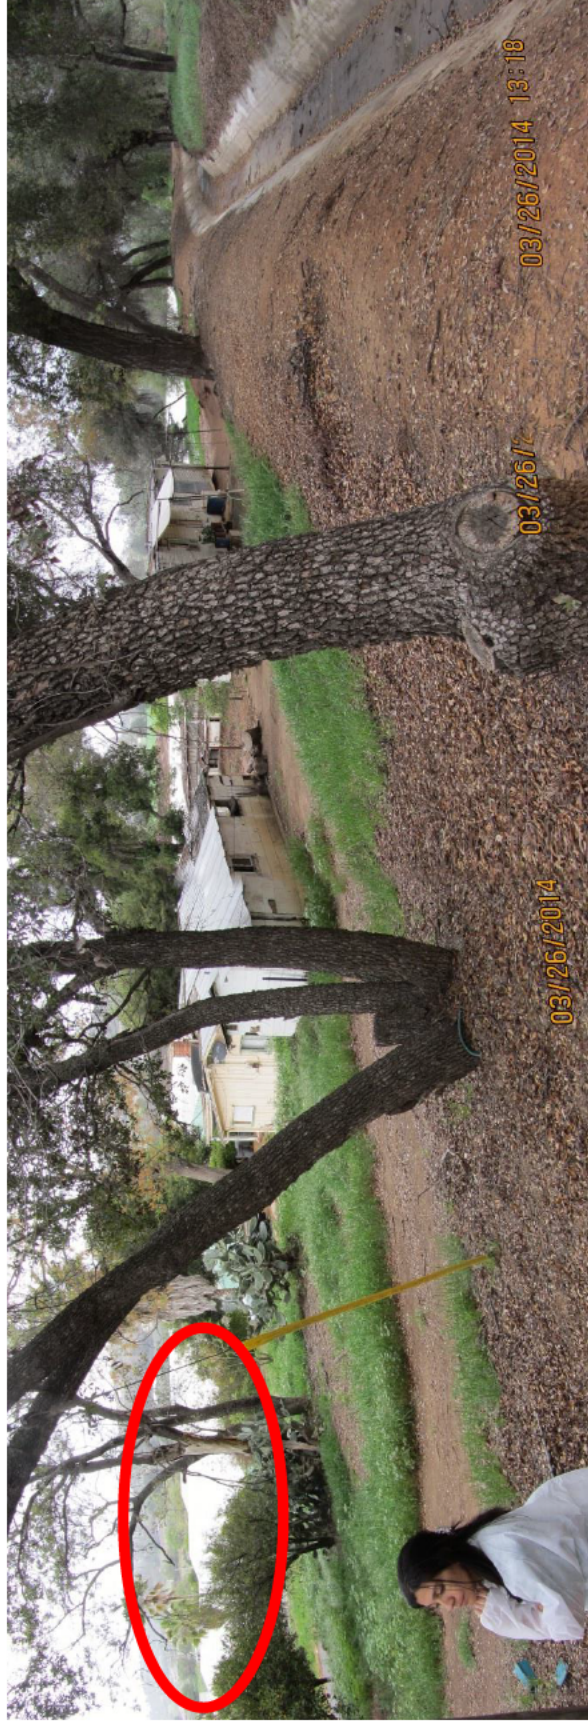
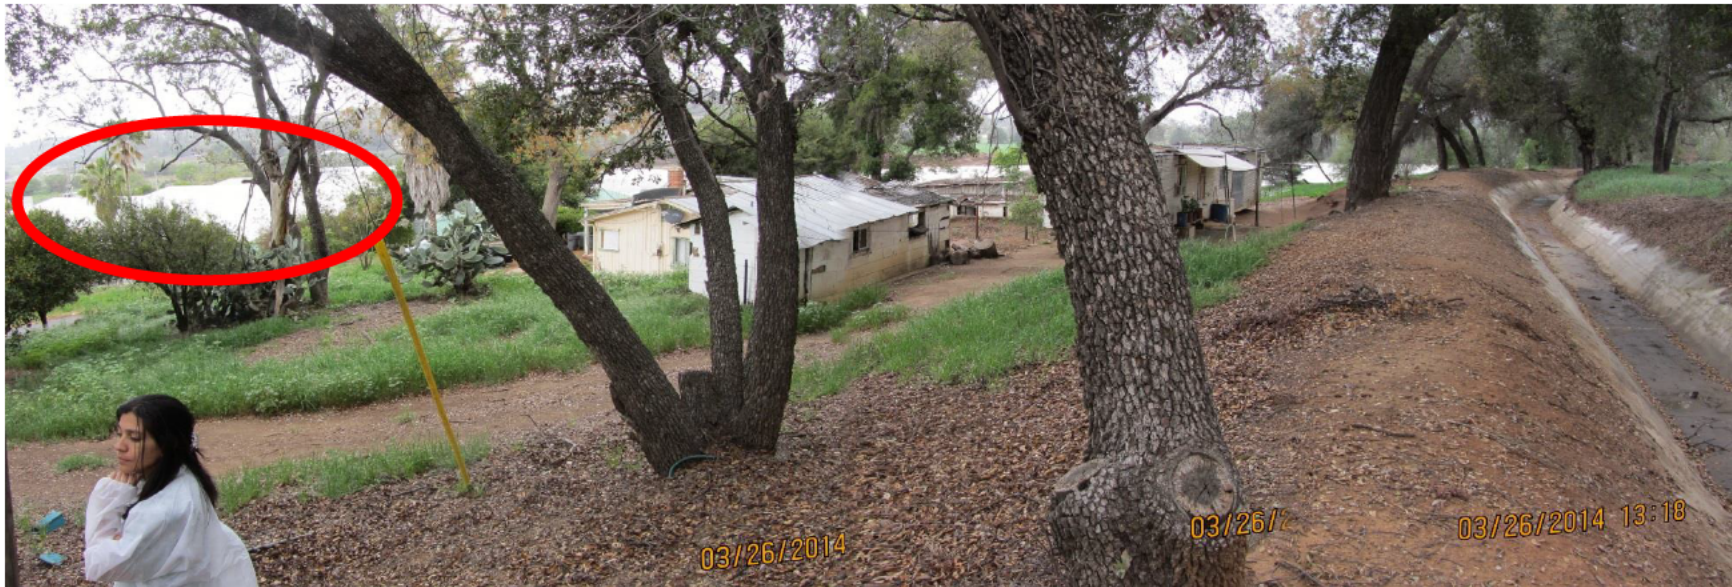
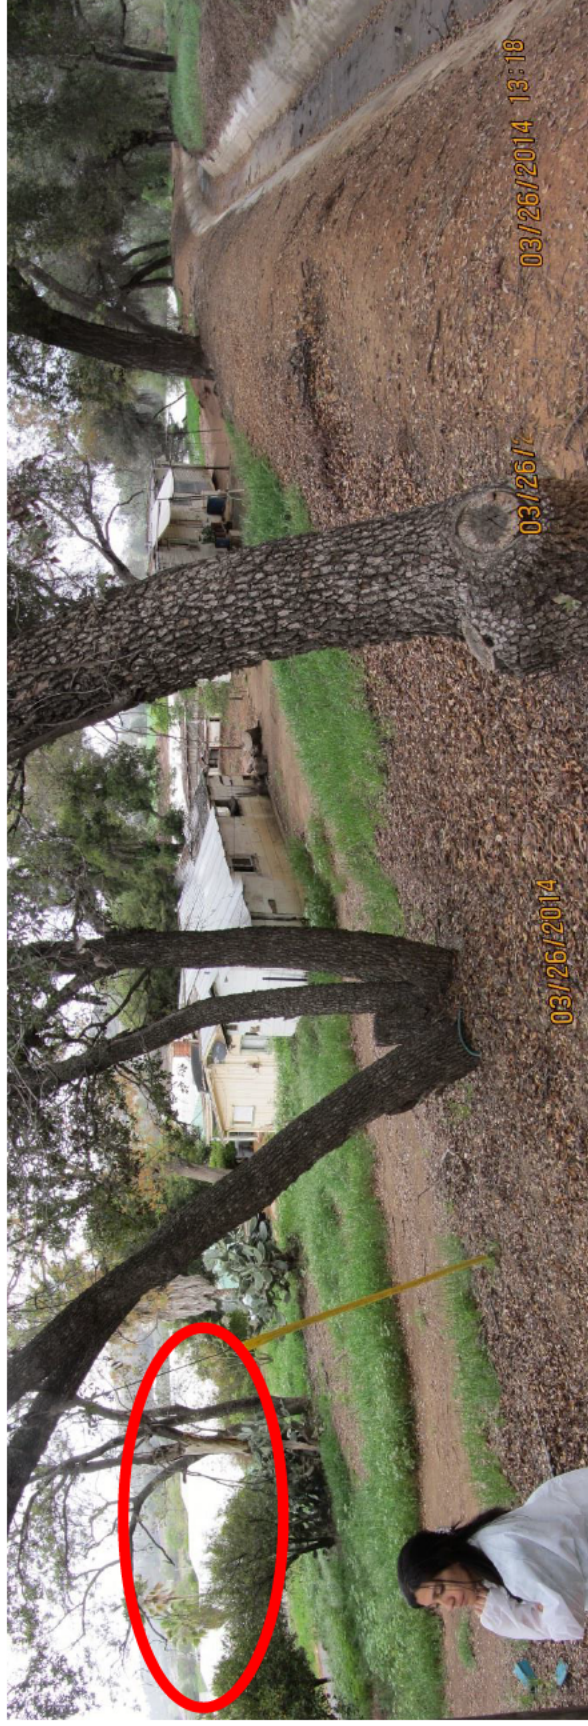
Photo 7 – View of canal running alongside and above the Armstrong Egg Farms facility. The canal is located uphill from the facility and does not appear to be able to receive flows from it. Circle marks hen houses downhill and to the west.

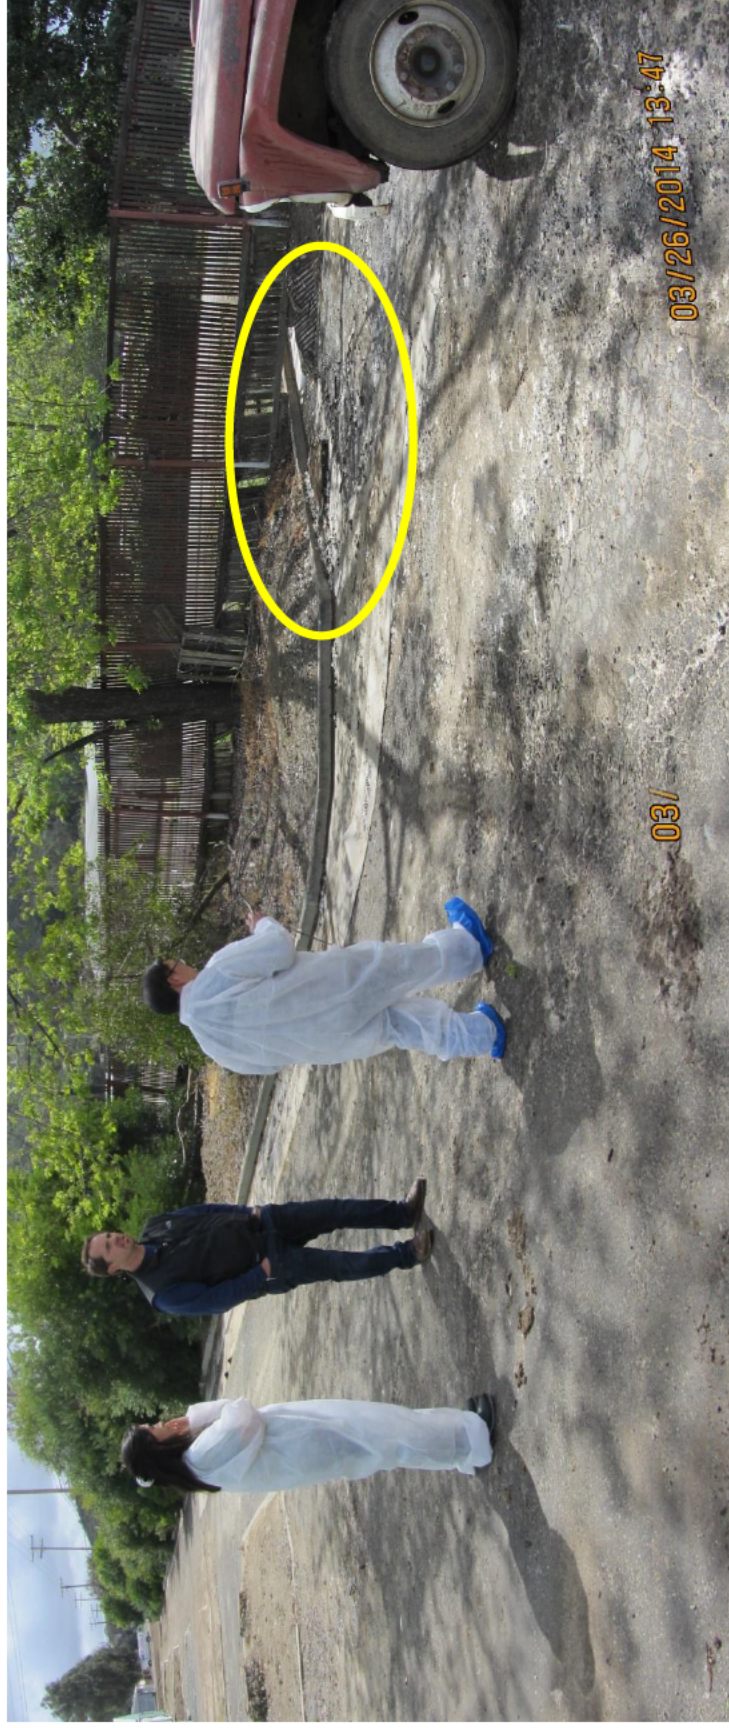
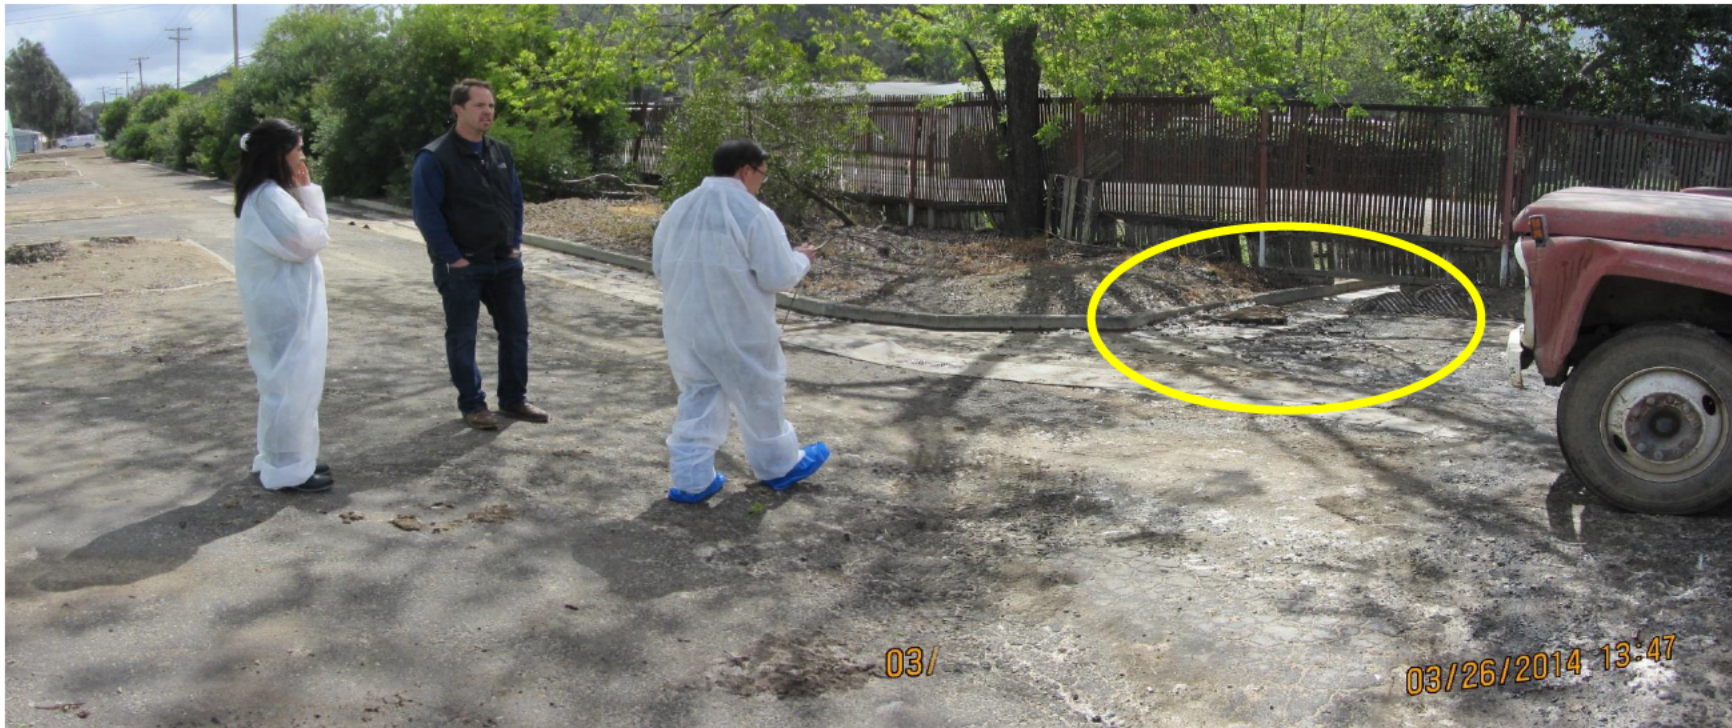
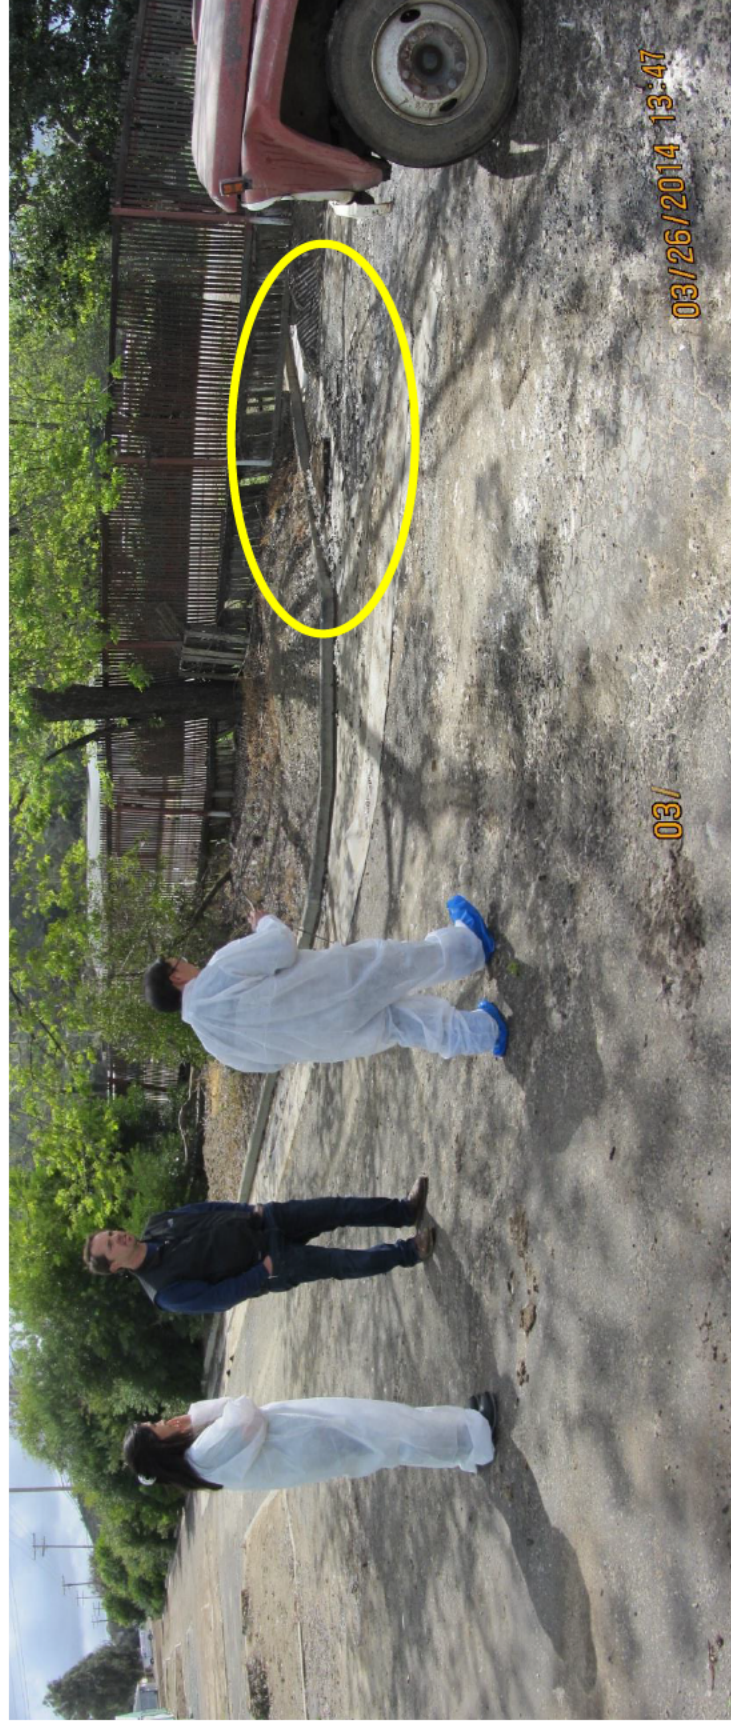
At the opening conference, I asked to inspect the following areas of the Site: the hen houses, stormwater and process wastewater conveyances, manure storage and handling areas, the perimeter of the Site, and any surface waters either adjacent to, or that might receive flows from, the Site. We began by visiting the nearest surface water – a canal located immediately adjacent to the eastern perimeter of the Site. It was apparent that this water body could not receive flows from the Site, as it was significantly uphill. Other than the canal, Mr. Armstrong said that Lake Wohlford was the nearest surface water, and he was not sure whether it might receive flows from the Site. He did volunteer that process wastewater (runoff from the Site, including flows from the manure processing area) had discharged on multiple occasions from the designated discharge point near the Site's northwest corner (see Photos 24-28 and 32).

Photo 24 – Stitched photograph showing the curb along the western perimeter of the facility, leading to the main discharge point (circled). On the right is the red truck seen in Photos 22 and 23. This shows the relative distance between the conveyor belt and discharge point.

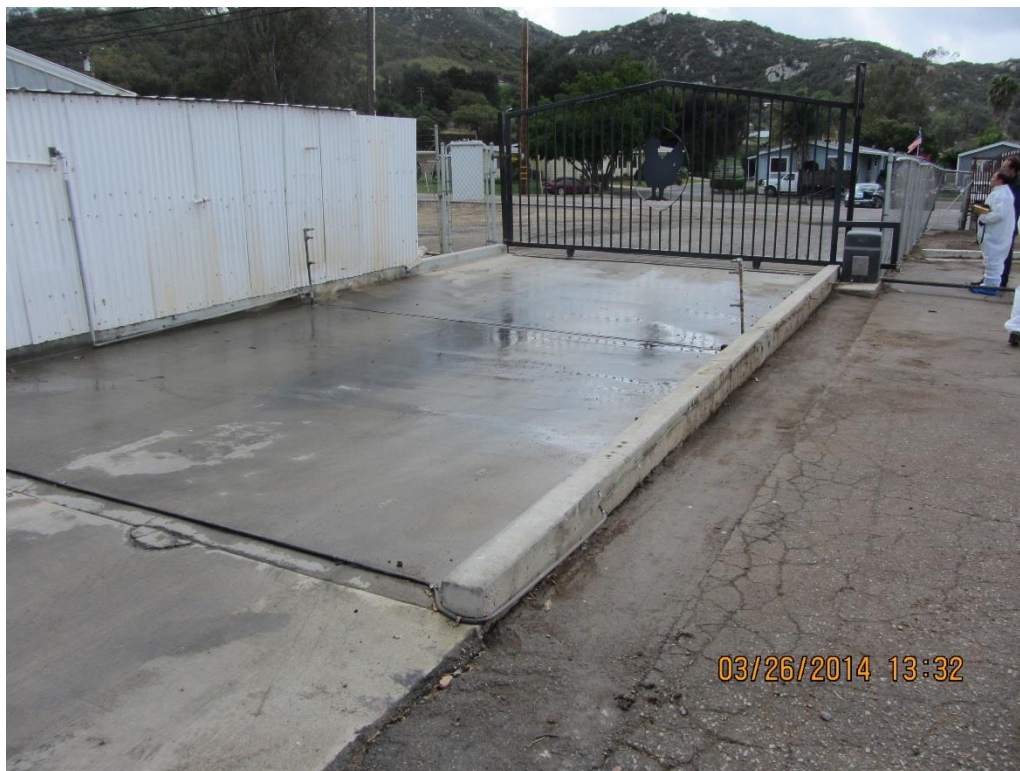
Photo 2 – View of vehicle wheel wash at facility entrance. Wash water sprays tires and is collected in an underground sump.

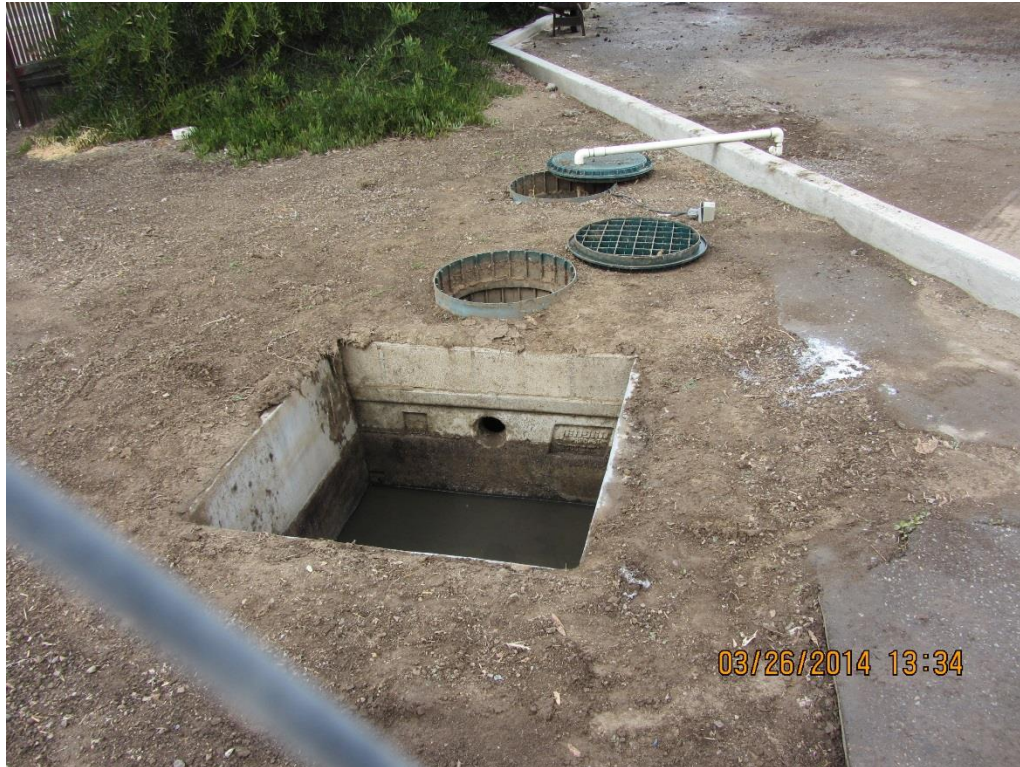
Photo 3 – View inside sump where wheel wash water is collected and reused. At the time we arrived, a vacuor truck was cleaning out the sump.

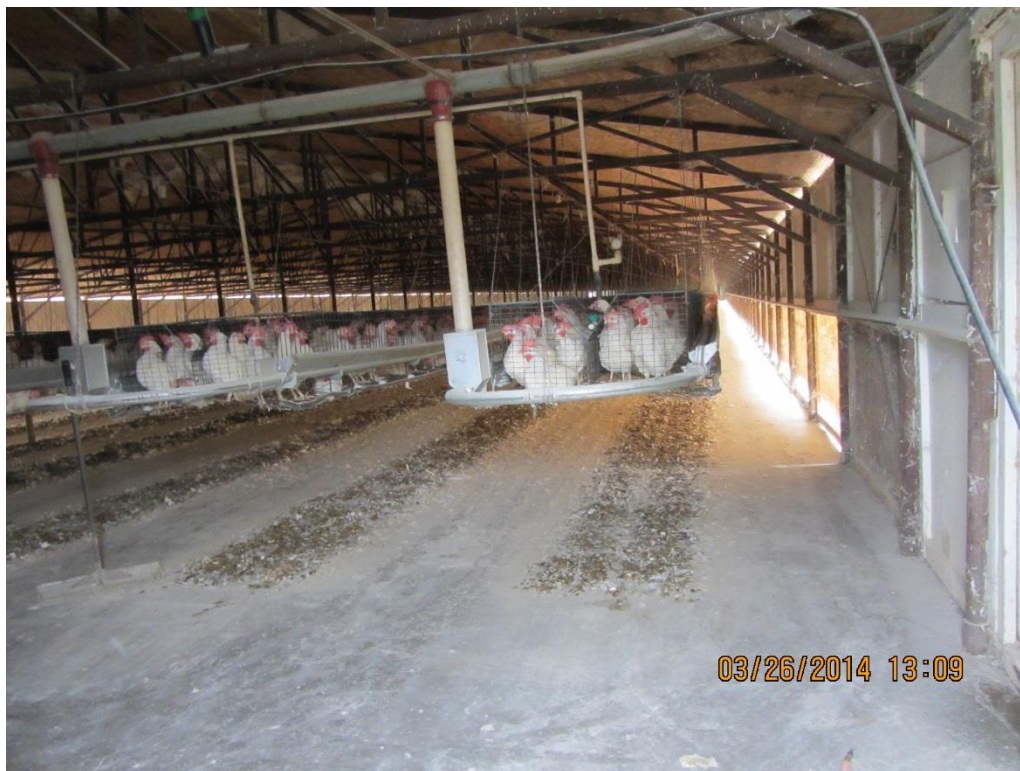
Photo 4 – View inside one of the hen houses. Manure falls to the floor and is scraped out by workers.

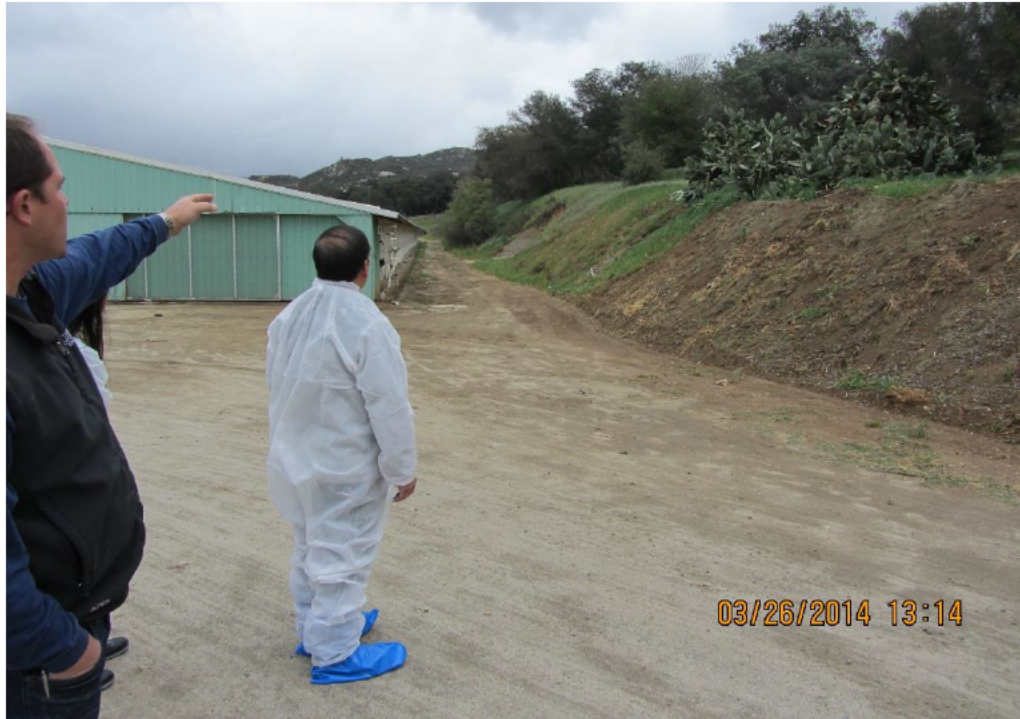
Photo 8 – View of the easternmost hen house adjacent to the canal in the previous photo. The earthen berm supports the western side of the canal. The bed of the canal lies above the level of the ground below.

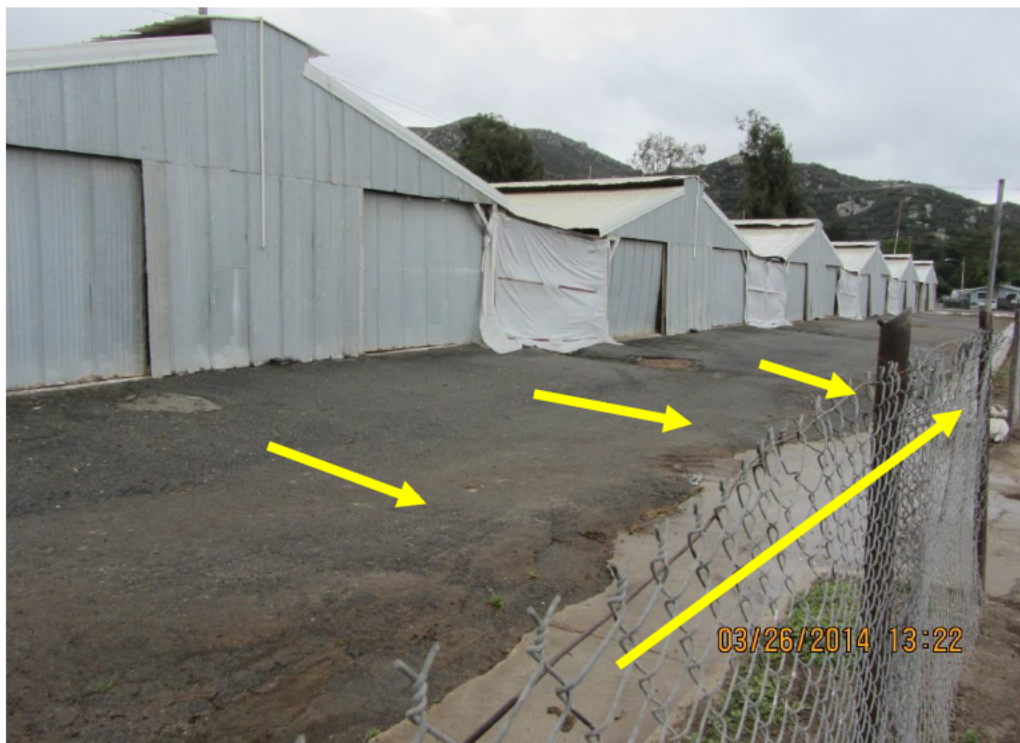
Photo 9 – Hen houses lined up in the southern portion of the facility. Arrows mark the likely direction of any stormwater flows, based on our observations of the topography and the operator's statements. Flow is downhill to the north, then west toward the roadway.

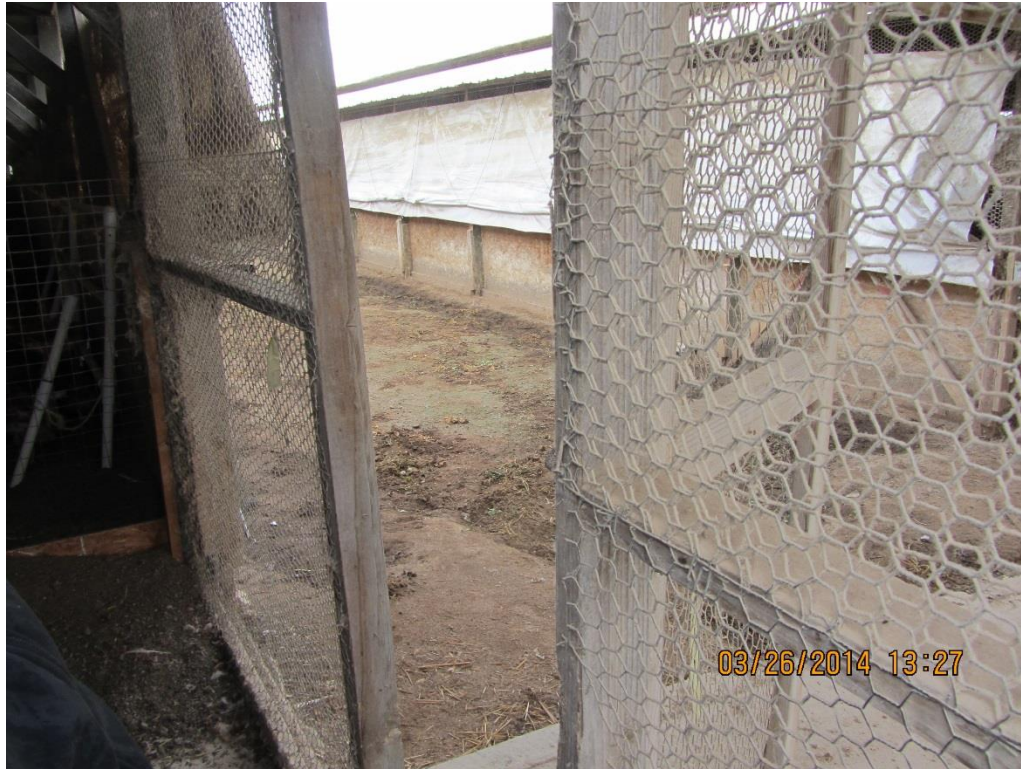
Photo 10 – View of the area between two of the hen houses in the previous photograph. Each of these areas discharges via a small culvert to the paved area immediately north. There did not appear to be much, if any, waste (feathers or manure) accumulated in these areas.

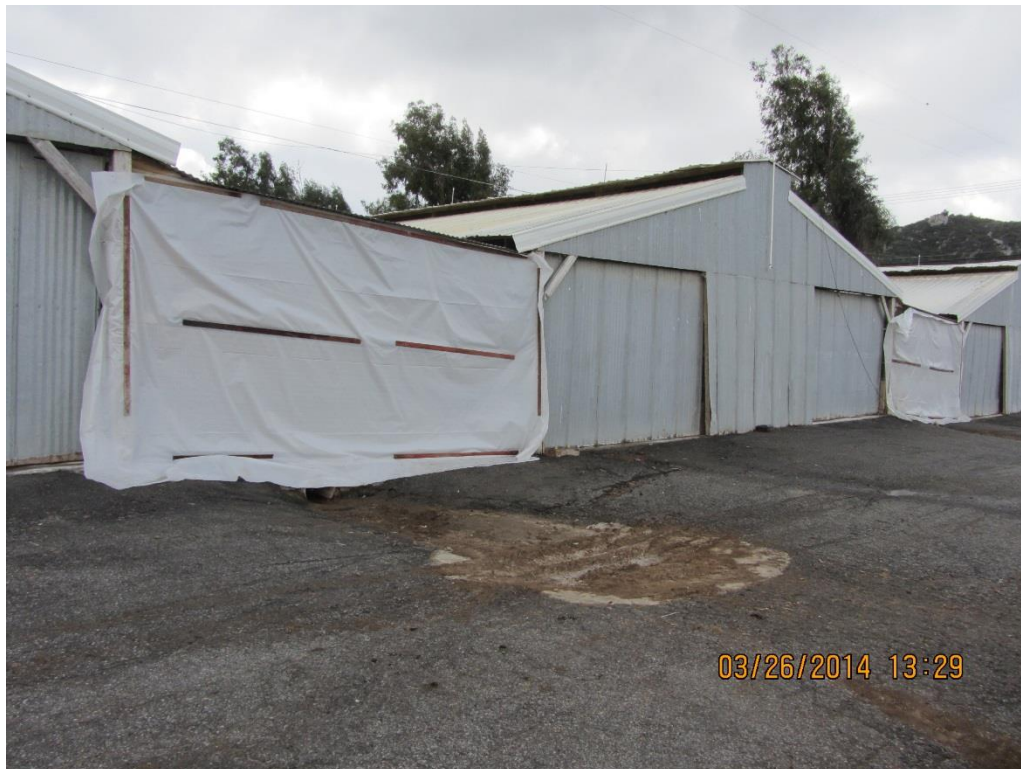
Photo 11 – View of one of the small culverts between the hen houses in photograph 9.

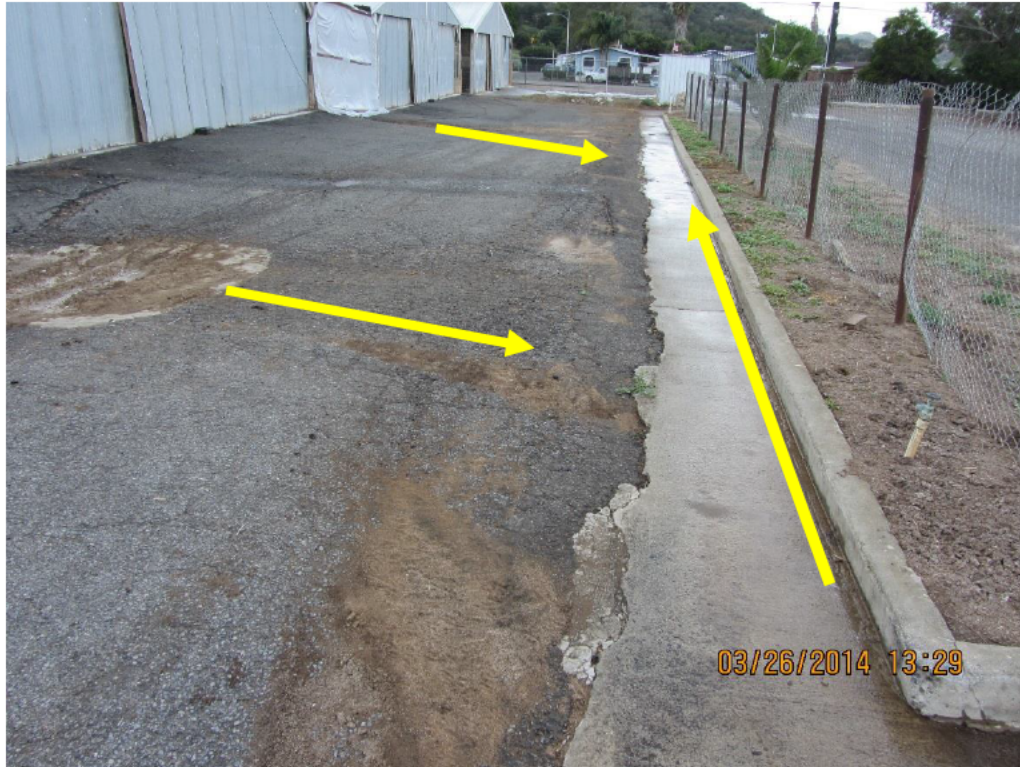
Photo 12 – Looking west along the curb in front of the hen houses in photos 9-11. Arrows show the direction of flow.

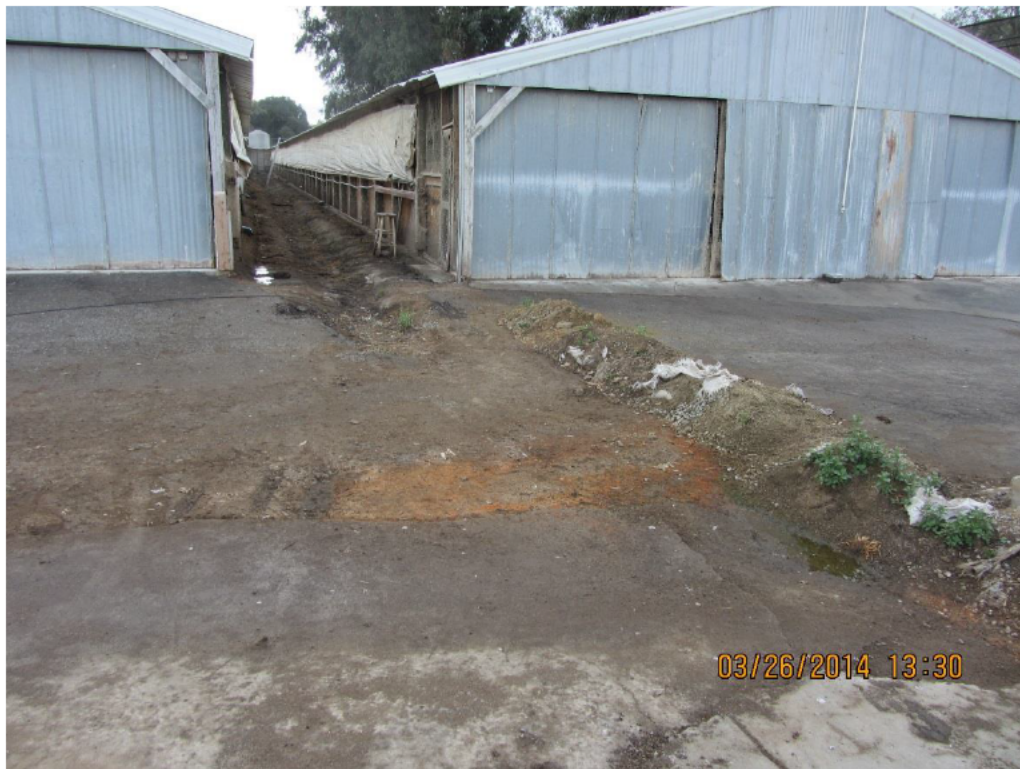
Photo 13 – Area between two hen houses graded to discharge in front of earthen berm. The berm can also be seen at the top of the previous photo.

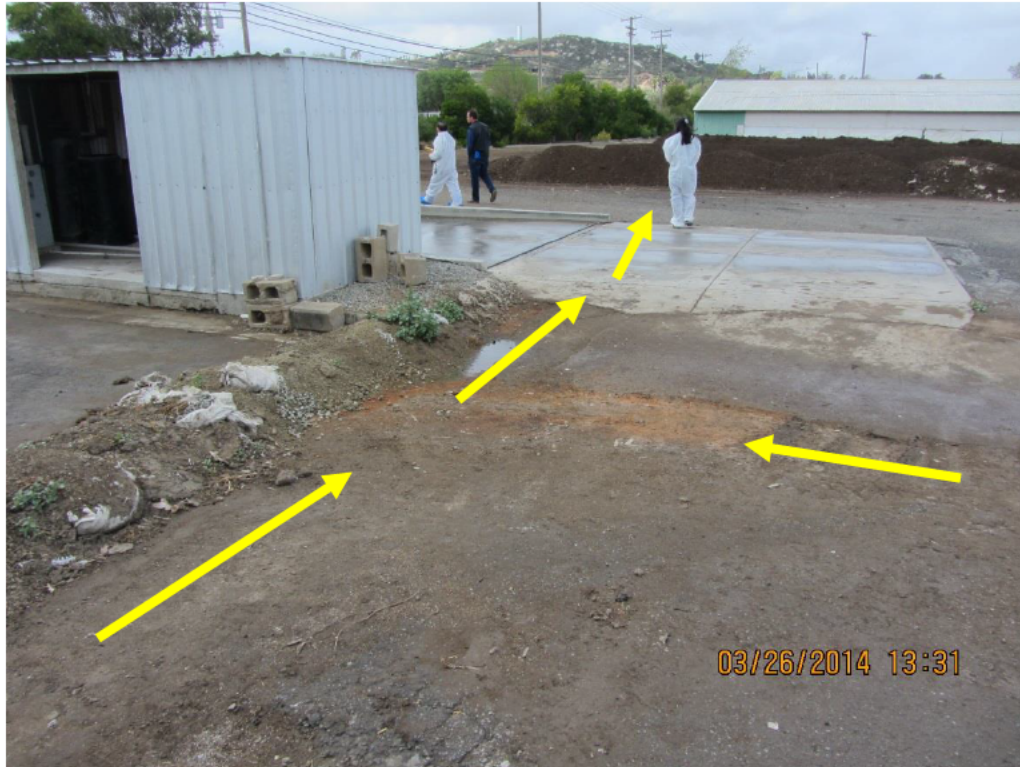
Photo 14 – View toward the northwest of the same earthen berm. It directs any flows from the hen houses in the south end of the facility across the pavement and toward the manure piles (see arrows).

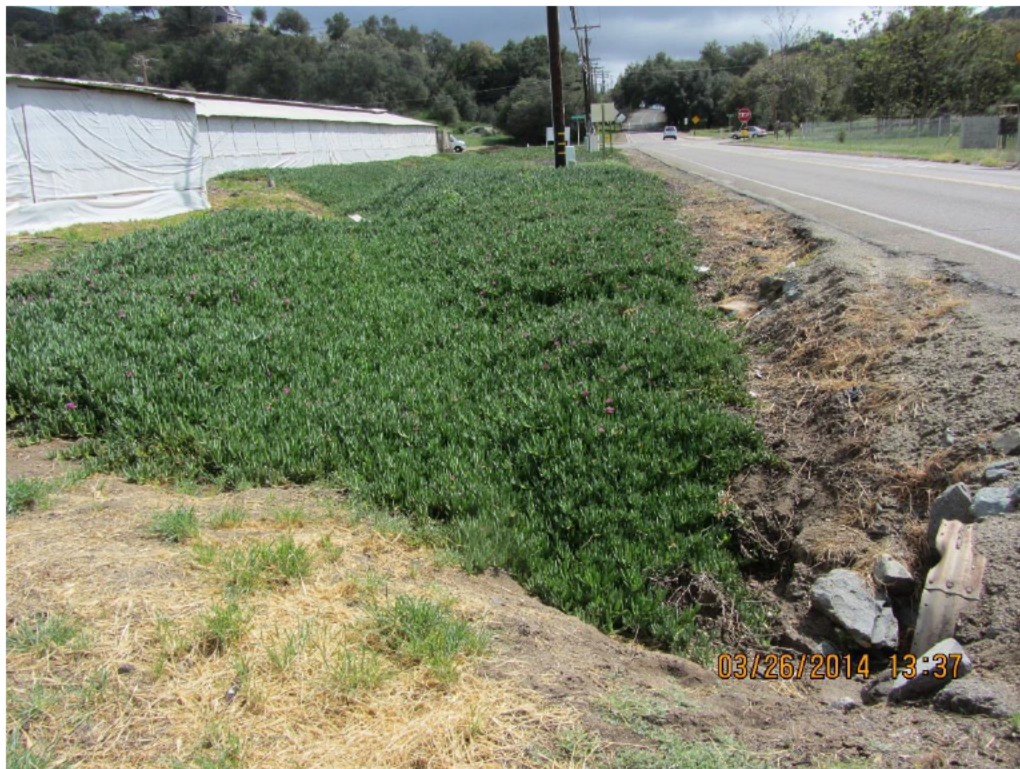
Photo 15 – Ditch running along the west side of the southernmost hen houses. The culvert carries flows westbound, under North Lake Wohlford Rd.
